Volume II

Appendix D.7

Working Scenario

The Working Scenario was the result of a joint effort between the Columbia Accident Investigation Board (CAIB) and the NASA Accident Investigation Team (NAIT). The report was written beginning early in the investigation to track the current understanding of the events that led to the loss of *Columbia*. As such, the report evolved over time as facts became known, theories were developed or disproved, and NASA and the Board gained knowledge of the accident sequence.

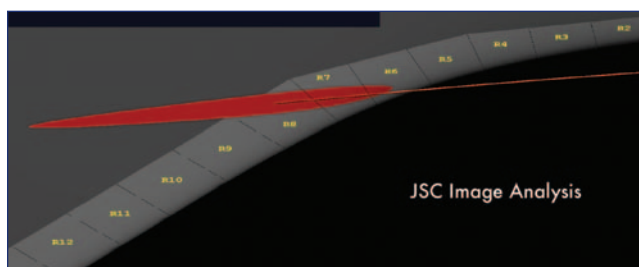
Figure 3-5. Multiple analyses determine foam impacted lower RCC panels 6 through 8 area.

Video and Computer-Aided Design (CAD) analysis determined that the most likely impact location was leading edge RCC panels 6 through 8 (Figure 3-5). Due to the foam size, RCC panels 5 and 9 must also be included in this impact zone. The best estimate of the foam size, based on imagery measurements, is 21 to 27 inches long and 12 to 18 inches

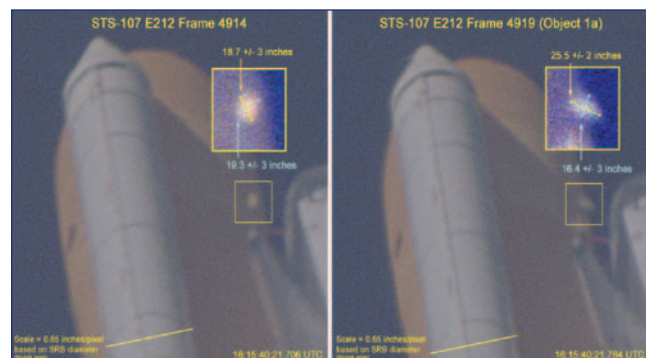
Figure 3-6. Photographic analysis techniques determined foam size: debris appears almost circular in frame 4914 and elongated in frame 4919.

wide. The precise foam shape and thickness cannot be determined from the available imagery; however, a reasonable estimate is that it was a plate-like shape and several inches thick. The foam tumbled at a minimum rate of 18 times per second based on the imagery, although the actual rate may never be known more accurately. Figure 3-6 illustrates a portion of the photographic analysis techniques used to determine the size of the foam.

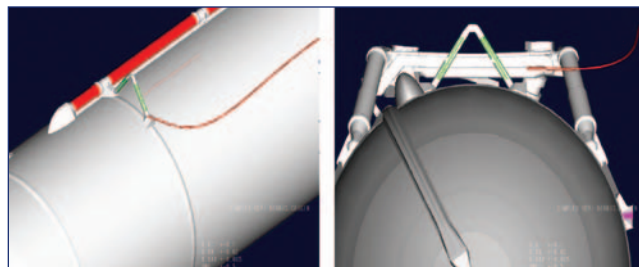
Figure 3-9. Multiple analyses indicate foam is from ET left bipod area. Red line depicts the estimated foam trajectory as it moved from the bipod ramp area toward the left wing.

There is significant visual and debris trajectory information to implicate the left bipod ramp area as the source of debris. In Figure 3-9, the red line depicts the estimated foam trajectory as it moved from the bipod ramp area toward the left wing. In addition to locating the impact in the RCC panels 6 through 8 region, the video analysis has also shown that the impact was below the apex of the RCC panels since no foam or post impact debris was observed to traverse over the top of the wing. This is indicative of an impact below the wing leading edge aerodynamic stagnation line (Figure 3-10). The stagnation line, or dividing streamline, is the line along the leading edge of the wing where the airflow comes to rest; above this line, airflow moves over the upper wing surface and below this line, the airflow moves over the lower wing surface.

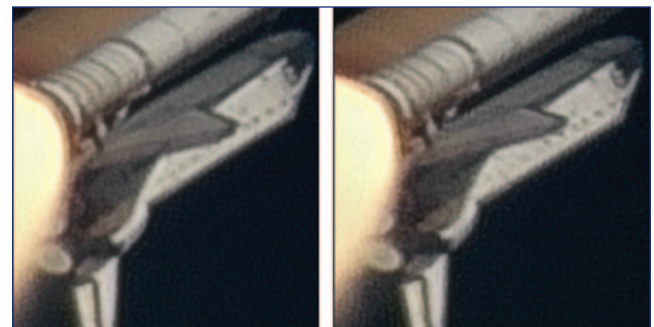
Figure 3-11. Pre-impact vs. post-impact shows no observable damage within the resolution limits.

Enhancements of the ascent video indicated there was no discernable damage to the orbiter wing leading edge or lower tile surface. Figure 3-11 is a sample of these video enhancements. The figure compares 30 pre-impact integrated video fields with 21 post-impact integrated video fields. Based on these enhancements, photo experts have been unable to determine or quantify any damage to any portion of the orbiter vehicle as a result of the impact.

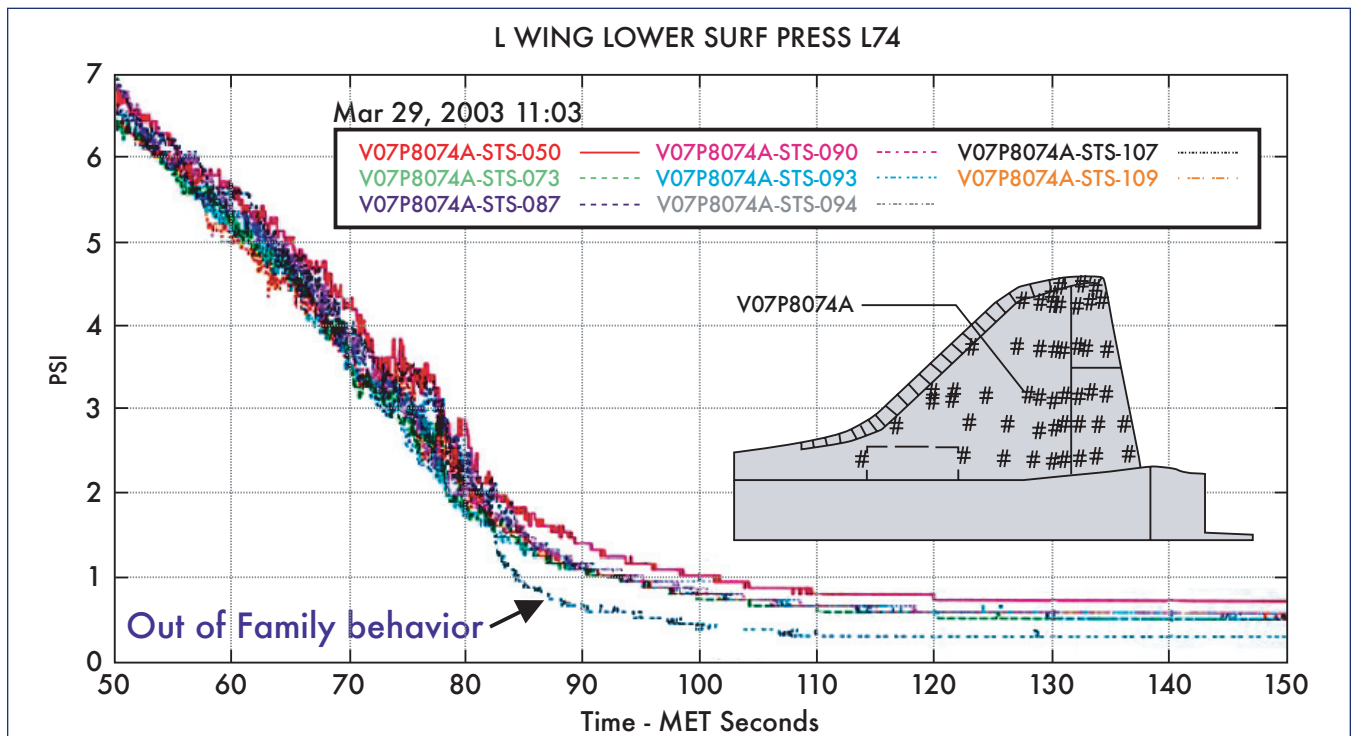
Figure 3-14. Unusual behavior of pressure sensor V07P8074A.

There are two other indications that the foam impact occurred in the panels 6 through 8 area. Two Modular Auxiliary Data System (MADS) lower surface pressure measurements behaved anomalously immediately after the time of the impact. Figure 3-13 shows the location of these measurements along with possible areas for post-impact debris re-contact in the vicinity of the sensors. The unusual behavior of one of the sensors is shown in Figure 3-14.

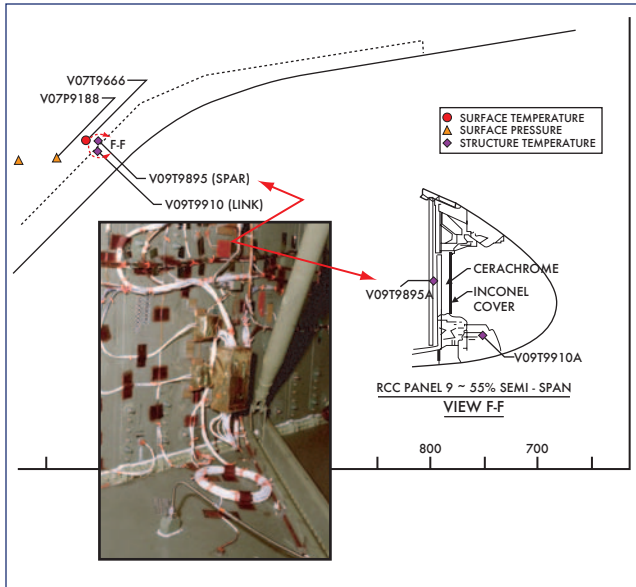
Figure 3-15. Close-out photo shows RCC panel 9 wing leading edge temperature measurement.

Additionally, there is another MADS measurement that had an off-nominal signature during the ascent timeframe. The temperature sensor on the leading edge spar behind RCC panel 9 showed a slightly higher temperature rise than seen on any previous *Columbia* flight. Figure 3-15 shows the location of the temperature sensor behind the wing leading edge spar inside the wing. The slight temperature rise can be seen in Figure 3-16. Note that most flights show a small rise in this temperature during ascent due to aerodynamic heating.

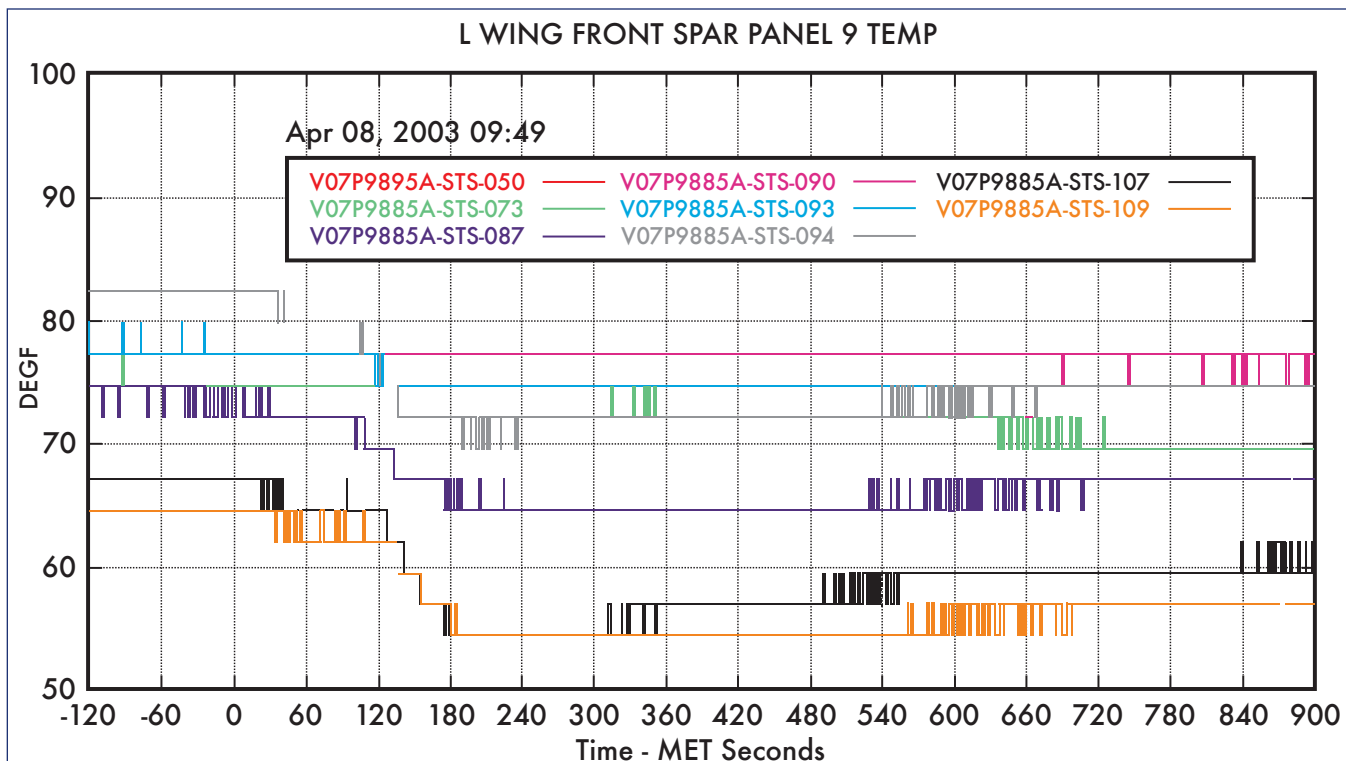
Figure 3-16. Three-bit rise (7.5 degrees F) on MADS wing leading edge spar temperature measurement (V09T9895A) during ascent.

STS-107 had a 7.5 degree Fahrenheit rise that started very early during ascent (five to six minutes after launch). Although the data do not prove that the RCC was breached during ascent, the data are consistent with a possible flow path into the RCC cavity via damage in the RCC panels 6 through 8 area. A simplified thermal math model was constructed and verified with flight data from STS-5. The model was then correlated to the flight data from STS-107. Assuming the equivalent heating from a 10 inch diameter hole in RCC panel 8, this model nearly predicts both the ascent and entry temperature profiles for the wing leading edge spar temperature sensor. Figure 3-17 compares the model with

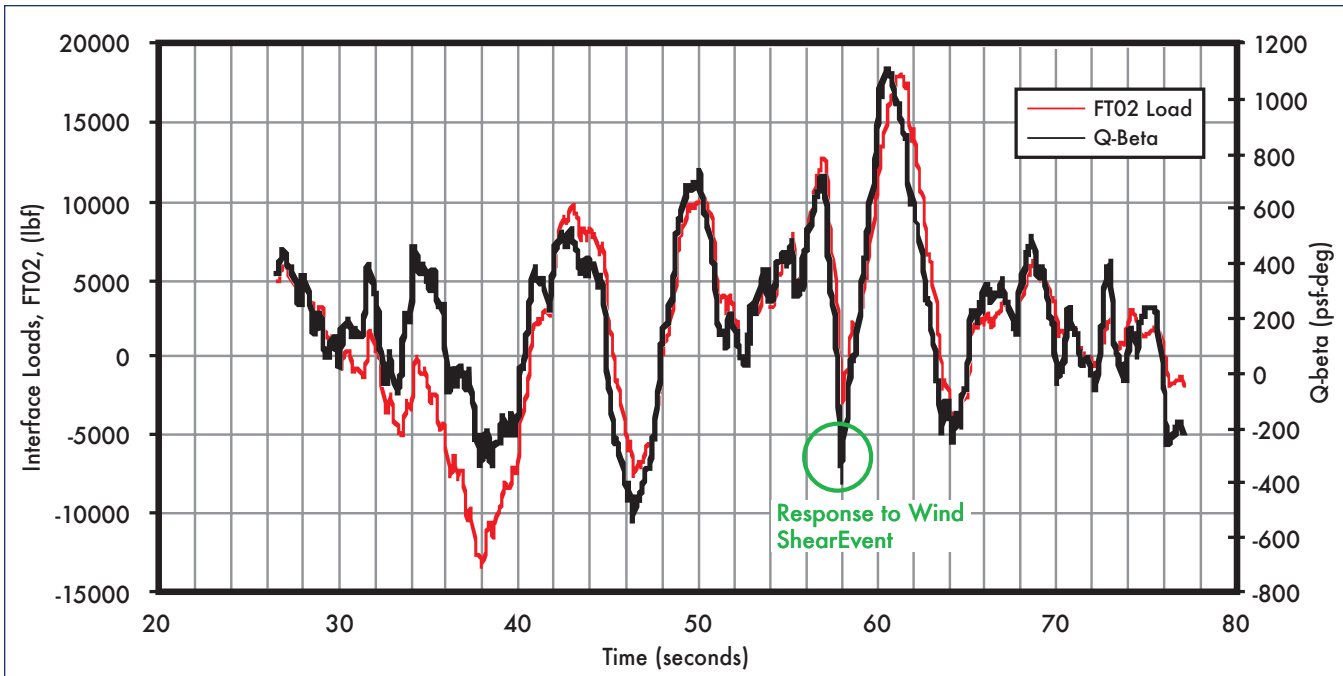
Figure 3-24. ET interface loads at forward attachment during wind shear and side-slip angle. Q-beta is side-slip angle multiplied by the dynamic pressure and represents the side-slip angle contribution of the interface load.

The ET/orbiter interface loads were generated using reconstructed trajectory parameters that included the effects of wind shear/crosswind, side-slip angle, and ET liquid oxygen (LOX) slosh. The loads analysis demonstrated that the ET forward attach loads were within certification requirements at all times. The wind shear event had only a small effect on the overall ET loads relative to the required limits (as shown in Figure 3-24), as did the ET liquid propellant slosh

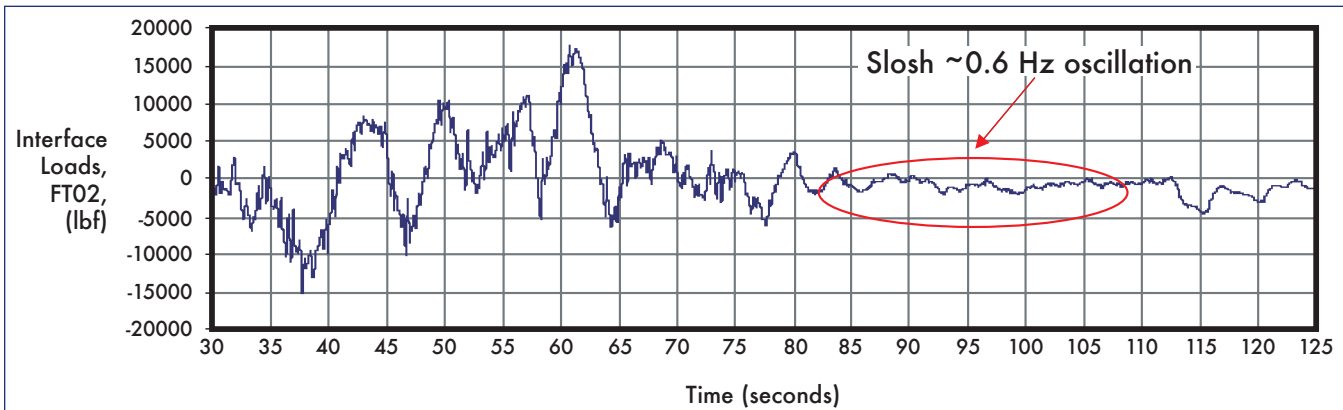
Figure 3-25. Slosh effect on ET interface loads.

(as shown in Figure 3-25). The resulting load from the wind shear event was of the same order magnitude as the roll maneuver and other first stage events prior to SRB separation.

The data from the ET LOX slosh study indicate that the flight control system operated as designed, and that more than adequate slosh phase stability margin existed. When the ET LOX slosh data is combined with the integrated vehicle loads analysis results (reference Figure 3-25), data indicate that the ET LOX slosh did not result in excessive vehicle loads at the orbiter/ET interface.

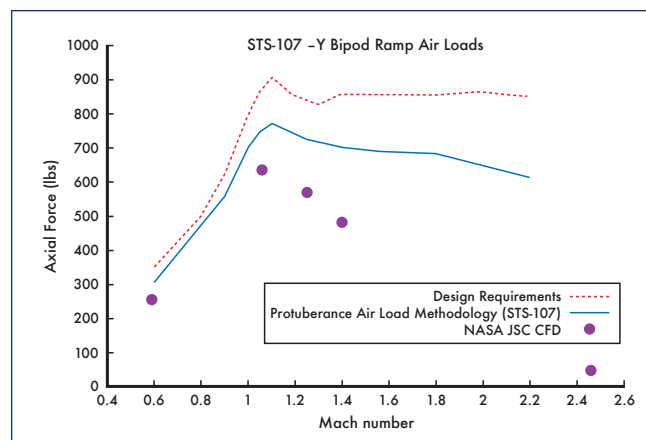
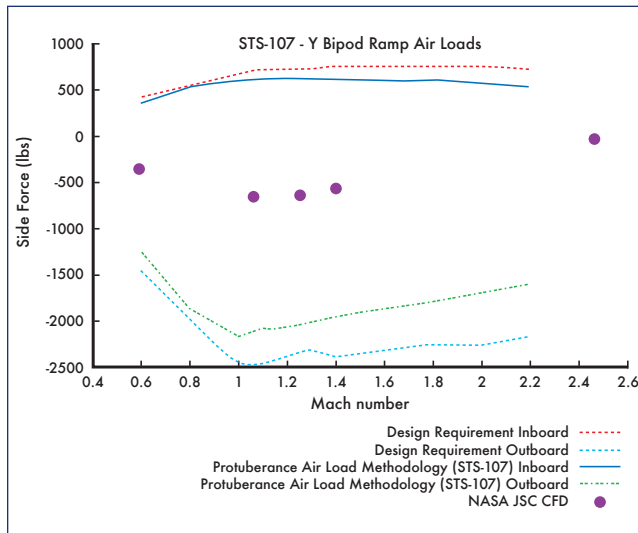
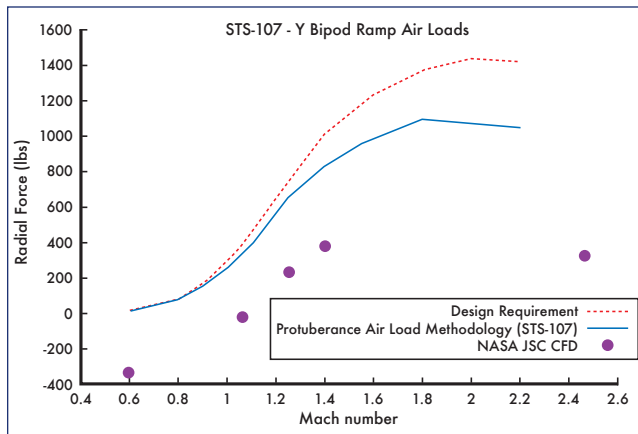
The external aerodynamic loads on the ET forward attach bipod were analyzed using a CFD simulation. The simulation produced axial, side-force, and radial loads as shown in Figure 3-26, Figure 3-27, and Figure 3-28, respectively. The CFD assessment of the bipod area indicated that the external air loads were below the design limit during the Hi-Q region and at the time of the bipod foam liberation.

Flexible body simulation results indicate that all vehicle elements and associated loads were within required limits. The reconstruction loads analyses indicate that the ascent environment-induced loads alone did not cause the ET bipod foam loss.

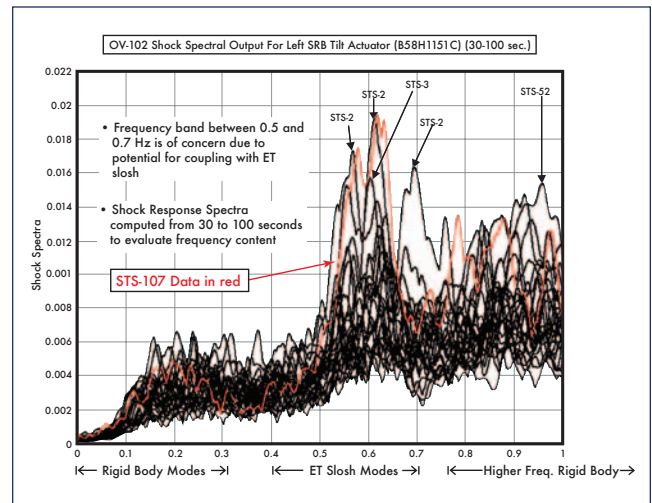
Figure 3-29. STS-107 SRB tilt actuators experienced more than typical 0.6 Hz content.

The STS-107 ascent data indicate a 0.6 Hz actuator oscillation frequency that peaks in amplitude at 55 seconds, and again at 77 seconds MET and continues through SRB separation. The peaks directly correlate to peaks in 0.6 Hz wind content. A 0.6 Hz oscillation in the Flight Control System output is of interest since it can couple with the ET Liquid Oxygen (LOX) slosh mode. Slosh refers to the repeated side-to-side movement of the center of gravity of the liquid oxidizer propellant in the external tank. The slosh mode frequency and amplitude cannot be measured directly through vehicle data. In order to determine if ET LOX slosh is present, a post-flight process of reviewing the vehicle SRB and SSME actuator frequency content must be conducted, as well as that of the launch wind. When this post-flight process was conducted for STS-107, it revealed that this flight experienced more than typical 0.6 Hz frequency content in the SRB tilt actuators with moderate content in the rock actuators. Figure 3-29 illustrates this point with the results of the SRB left tilt actuator frequency response as compared to previous *Columbia* flight history.

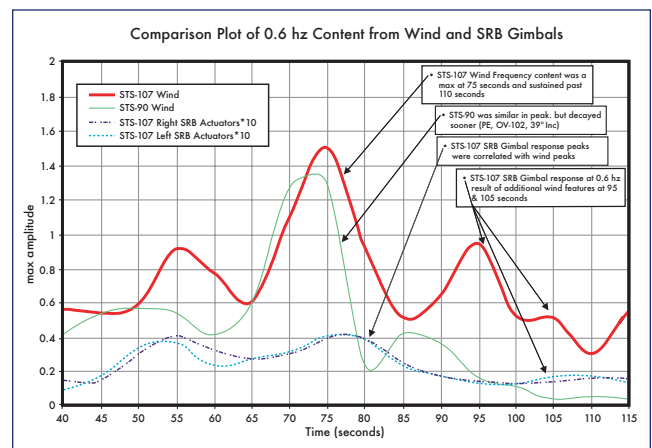
Figure 3-30. STS-107 SRB gimbal responses at 0.6 Hz frequency correlated to wind.

Figure 3-30 shows the relative time variation of amplitudes of the 0.6 Hz frequency content in wind and actuator data. The close correlation between the peaks in the 0.6 Hz content of the right and left actuator responses and the wind dynamics indicates that the actuators were responding primarily to wind rather than ET LOX slosh at this frequency through most of first stage (prior to SRB separation). As the 0.6 Hz content of the wind dynamics reduces in magnitude late in first stage, the remaining 0.6 Hz content in the actuator response may be attributed to a combination of the remaining wind dynamics and low-amplitude ET LOX slosh. STS-90 shows a similar wind frequency content.

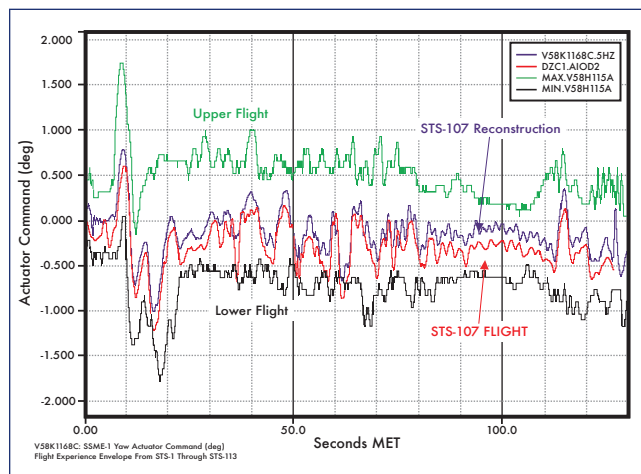
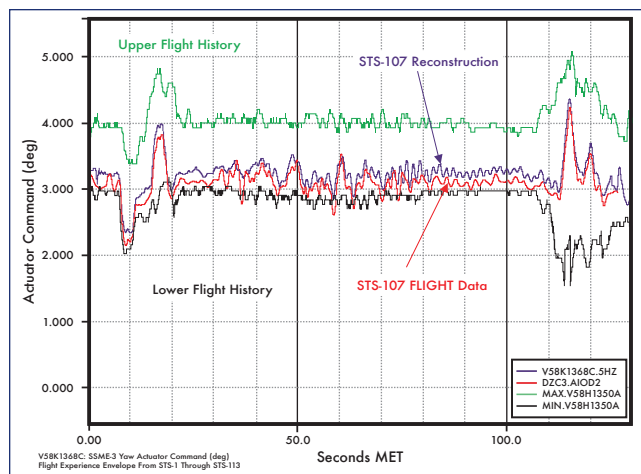
A review of the STS-107 ascent data identified two discrete points in time when the SRB and SSME nozzle positions exceeded the flight experience envelope for those respective times in the ascent profile. The first event occurred when the center and right SSME yaw deflections exceeded the previous flight experience envelope during the period of maximum dynamic pressure, as a result of the differences between predicted and actual flight wind conditions (as shown in Figure 3-31 and Figure 3-32).

This nozzle yaw event was coincident with a wind-induced positive lateral acceleration, as sensed via the body mounted accelerometer assemblies and a positive orbiter body yaw

rate, as sensed by the orbiter rate gyro assemblies. The yaw event follows the period of greatest change in out-of-plane wind velocity (e.g., the wind shear previously shown in Figure 3-21).

The large offset in the Center and Right SSME yaw positions at 62 seconds MET was the reaction of the flight control system to the wind shear event and day-of-launch wind differences as compared to the DOLILU design. The nozzle motion was within the capability of the Shuttle flight control system, and the system operated as designed. As discussed in Section 3.5.1, the reconstruction loads analyses indicate that the ascent environment-induced loads alone did not cause the ET bipod foam loss.

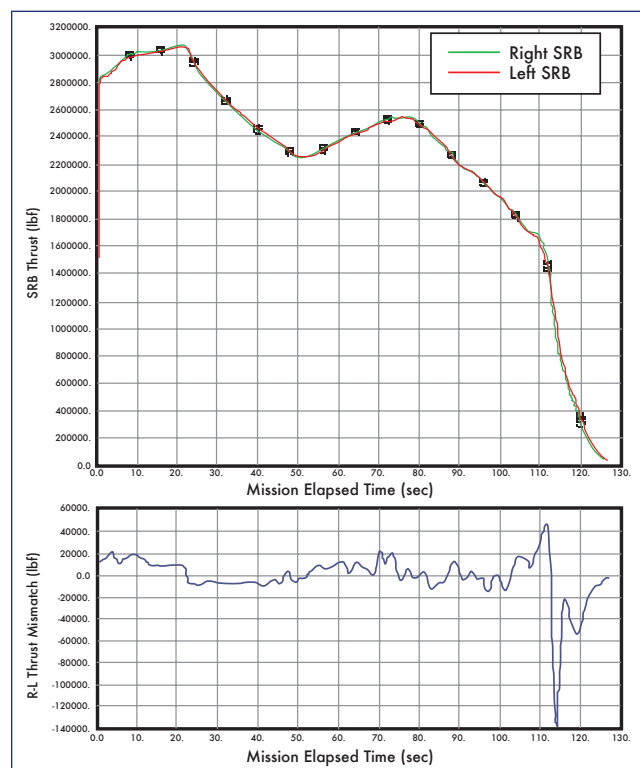
Figure 3-34. SRB thrust mismatch.

The SRB thrust mismatch observed during tail-off was well within the design margin of the flight control system, and similar occurrences have happened numerous times during previous flights.

The data indicate that the SRB thrust mismatch on STS-107 was a direct result of SRB burn rate differences between the left and right SRB. The thrust mismatch observed on STS-107 and the new flight experience nozzle positioning occurred after the foam shedding event. The SRB thrust mismatch occurred on the majority of flights in both families of flights, including those that did not shed foam.

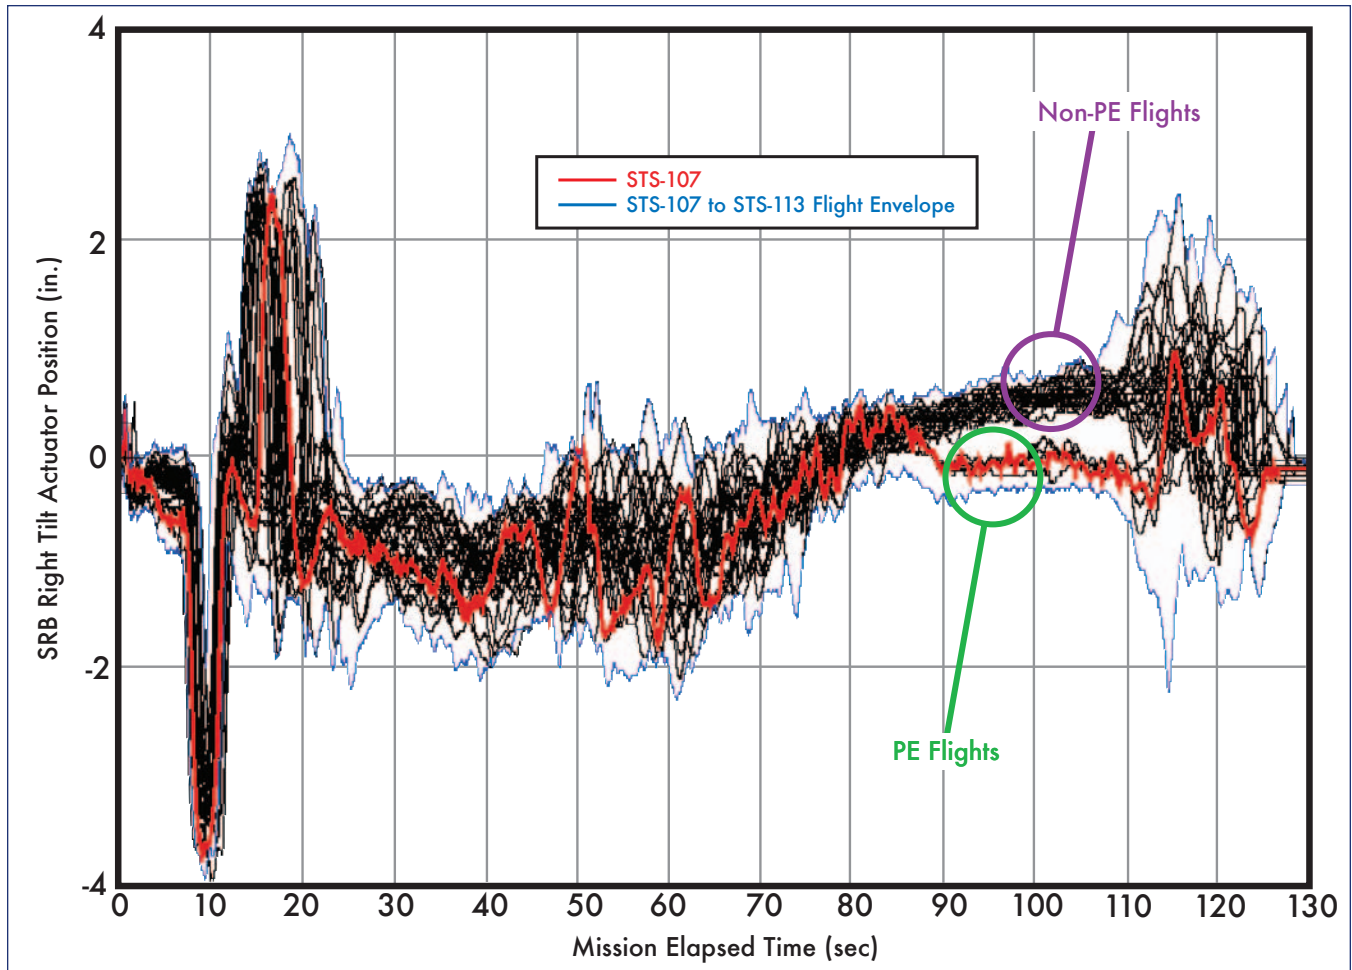
Figure 3-35. SRB nozzle position for PE flights versus non-PE flights.

The second nozzle motion event occurred when the SRB and SSME Thrust Vector Control (TVC) pitch and yaw deflections exceeded the previous flight experience envelope during SRB tail-off (as the SRB thrust diminished). The new flight experience envelope for the SSME and SRB nozzle positions was primarily due to (1) low Reusable Solid Rocket Motor (RSRM) performance that caused a time shift of the SRB tailoff events relative to previous flight experience, as indicated by a low burn rate shown in Figure 3-33, (2) a thrust mismatch between the left and right SRB caused by lower than normal thrust on the right SRB during tail-off, the final seconds of SRB burn (as shown in Figure 3-34), (3) a small bias in the left SRB pitch actuator that shifted the actuator positions farther toward the edge of the flight experience envelope, and (4) flight control trim characteristics unique to PE flights (as shown in Figure 3-35).

Due to flight control gain settings unique to PE flights, PE flights have a nozzle position closer to zero inches deflection from 85 to 110 seconds MET. The flight data that coincides with the STS-107 data are all from PE flights, seen clearly in the 85 to 110 seconds MET timeframe in Figure 3-35. The other grouping of flights in this same timeframe (85 to 110 seconds MET) are all non-PE flights and have larger pitch nozzle deflections.

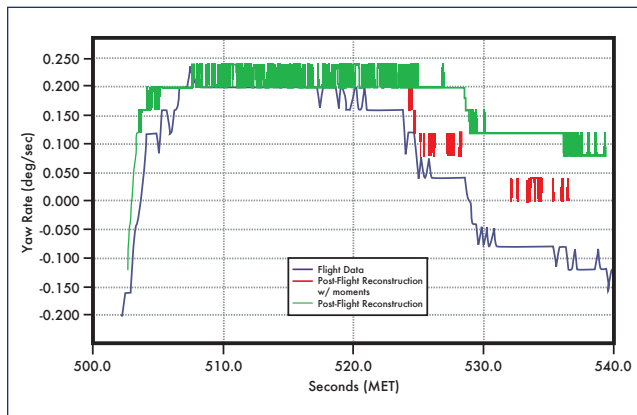
Figure 3-36. ET separation yaw rate.

A higher than typical negative yaw rate was observed at ET separation during STS-107. The yaw rate, shown in Figure 3-36, was approximately -0.12 deg/sec and near the edge of the flight experience envelope. The negative yaw rate is noteworthy because it does not correspond to the flight control system's thruster activity, known vent forces, or any other explained mission activity. Furthermore, the rate appears at the time of physical separation between the orbiter and external tank, which indicates that it is related to the structural release between the two objects. Although the negative yaw rate was unusual, it was well within the design and certification envelope for ET separation. This rate was also well within the flight limits (± 0.7 deg/sec) for ET separation to occur.

A fault tree analysis narrowed down the cause of the negative yaw rate to a release of strain energy at ET separation due to either (1) a misalignment of the orbiter and external

Data indicate that the yaw rate at ET separation did not result in re-contact between the orbiter and the ET after separation. This observation is based on high rate telemetry (25 Hertz) orbiter body rate data, and MADS accelerometer data analyzed post-flight. The yaw rate was within the expected range of vehicle body rates when taking into account all known error sources, including rate sensor noise. The data indicates that no correlation exists between observed yaw rate at ET separation and bipod ramp foam loss.

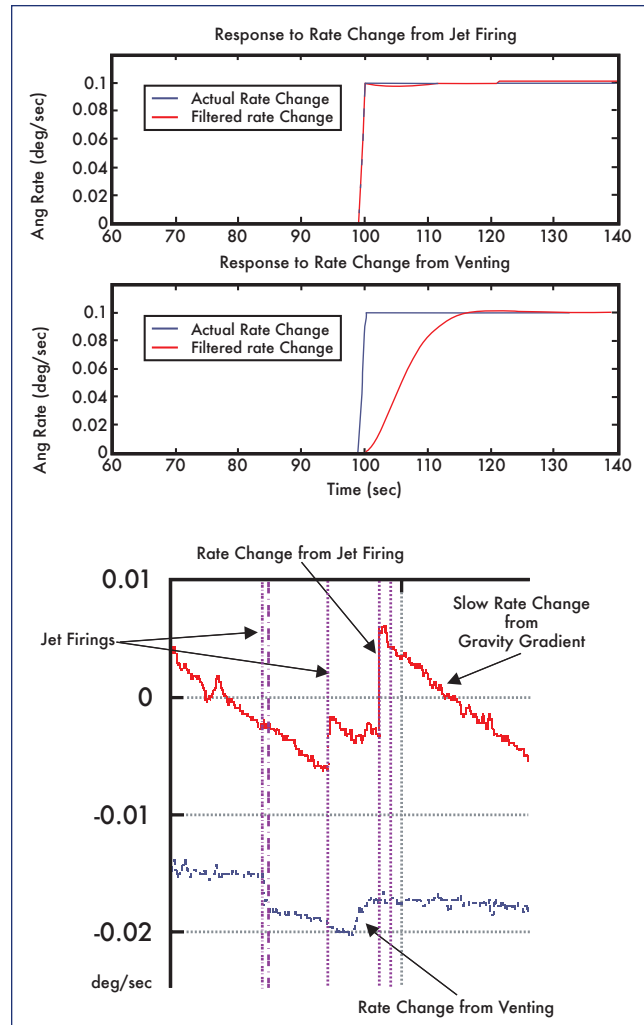
Figure 4-1. Jet firing example for vehicle rates

The On-Orbit DAP will command jets to fire to maintain attitude errors within attitude deadbands and rate errors within rate deadbands. During periods of attitude hold, the majority of jet firings are due to the attitude deadband. Rate deadband firings typically occur at the beginning and end of attitude maneuvers, and during maneuvers due to changes in the desired rate. Figure 4-1 depicts changes in the vehicle rates due to jet firings and normal gravity gradient forces.

firings not screened. The final result was that there were no unexplainable jet firings in the STS-107 on-orbit data.

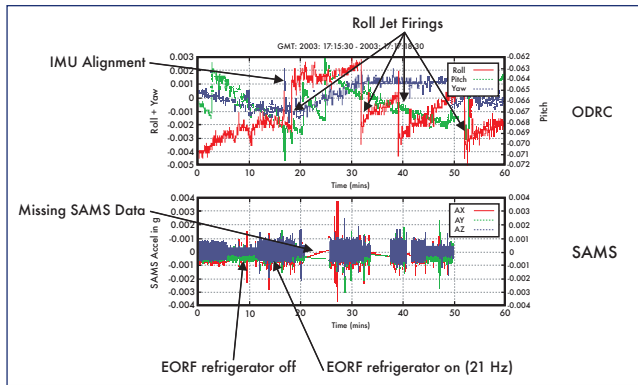
Figure 4-2. Sample data from SAMS and ODRC.

SAMS data was used to support the aforementioned IMU rate data review. Anomalies in rates from manual review of orbiter body rates were compared to SAMS measurements to help identify sources. Figure 4-2 provides a sample plot of SAMS data and the response signature to an IMU alignment and the Enhanced Orbiter Refrigerator/Freezer (EORF) operation, as well as downlisted telemetry in the Operational Data Retrieval Complex (ODRC) system. SAMS data was also scanned for large transients to identify potential strikes (the assumption is that a hypervelocity impact would “ring” the structure). Various frequencies from nonstructural items were identified, so that they could be filtered out of the data. Figure 4-3 shows the frequency response of several items such as the EORF refrigerator and the Ku-band antenna. A detailed structural model that identifies frequencies of primary structure was developed. This model was used to screen for vibrational transients associated with orbiter wing strikes.

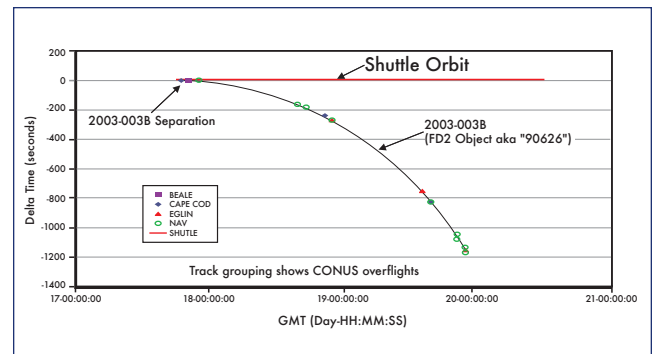
Figure 4-4. Tracking of flight day 2 object through various sensor passes.

The calculated departure velocity was relatively low and was estimated to be 0.7 to 3.4 miles per hour with the lower velocity being more likely. An exact departure direction relative to the orbiter could not be determined. Multiple ground sensors including Eglin Air Force Base (AFB), Beale AFB, Cape Cod Air Force Station (AFS), and the Navy Space Surveillance fence radar tracked the object. The object reentered the atmosphere on January 19 between 20:45 EST and 23:45 EST. Figure 4-4 depicts the tracking of the object including various sensor passes.

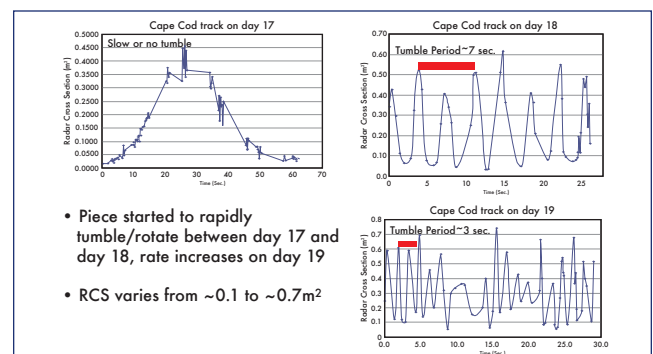
Figure 4-5. On-orbit RCS shows increased tumble/rotation rate over time.

Based on the observed radar cross sections, the object appeared initially to have a minimal to no tumble/rotation rate, but it gradually developed a rate over the next two days. During a Cape Cod AFS sensor pass on January 18 at 15:29 EST, the tumble/rotation rate had a period of seven seconds. Later, on January 19 at 10:39 EST during another Cape Cod AFS pass, the apparent tumble/rotation rate had increased and the period was approximately three seconds. Figure 4-5 depicts the tumble/rotation rates during the timeframe that the object remained in orbit. The exact physical size and mass of the object are unknown, although it appeared to be a lightweight piece based on the observed ballistic coefficient.

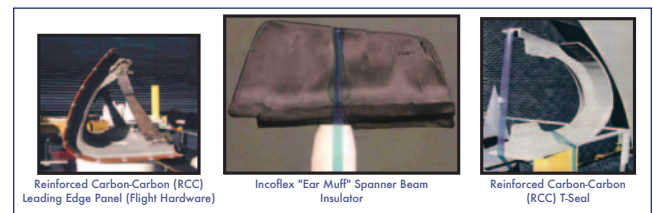
Figure 4-6. Leading edge structural subsystem components matching RCS and ballistics.

The results of this radar testing and ballistics analysis have excluded all external Shuttle materials with the exception of 1) a whole Tee seal, 2) a Tee seal fragment that includes an attachment flange and/or apex segment, or 3) RCC panel acreage no less than 90 square inches and roughly square in shape (+/- 20%), although curvature is possible, with a thickness on the order of 0.33 inches. An RCC panel segment matches the RCS and ballistic performance characteristics observed during the STS-107 mission.

A Tee seal fragment with an apex segment matched the RCS characteristics extremely well in any spin orientation; however, the ballistic match required a very specific spin orientation that was shown to be feasible in one analytical simulation. Therefore, it is possible that the flight day 2 object was either a partial Tee seal or RCC panel acreage piece. The Incoflex spanner beam “ear muff” insulation was also a good match for both ballistics and RCS. Because the “ear muff” is situated behind the RCC panel, it is excluded from being considered a very likely candidate because of the lack of a mechanism for exposing it to the space environment. If the damage to the wing were actually a 10-inch diameter, uniformly round hole, then an “ear muff” would be a more plausible candidate. However, it is considered unlikely that the wing damage was a 10-inch diameter round hole. The damage is considered to be the equivalent of that which would provide the same thermal response during entry as a 10-inch diameter hole did in the analyses and simulation. It is not likely that the actual wing damage was geometrically uniform. The damage was more likely a combination of cracks and holes, or a slot, such as a Tee seal or partial Tee seal missing or displaced. Therefore, the ear muff is not considered to be a good candidate for the flight day 2 object. Figure 4-6 shows the three leading edge

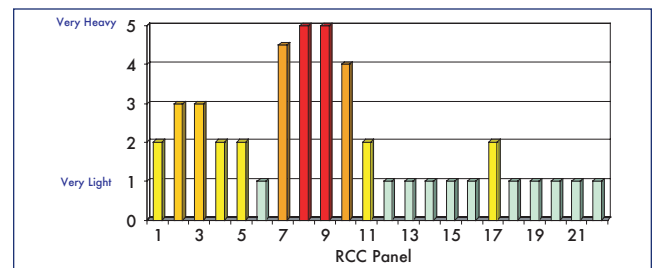
Figure 5-2. Slag deposition in the RCC panel 8/9 area relative to the other parts of the left wing leading edge.

The forensic data indicate that the panel 8/9 area was subjected to extreme entry heating over a long period of time leading to RCC rib erosion, severely slumped carrier panel tiles, and a substantial slag deposition on the upper portion of RCC panels 8 and 9. Figure 5-2 shows the slag deposition (both metallic and oxide) in the RCC panel 8/9 area relative to the other parts of the wing leading edge, and Figure 5-3 shows samples of the severe slag deposition on the panel 8 rib. A review of all recovered debris indicates that this is the most probable area of a breach into the wing since there are no other debris pieces that exhibit the unique characteristics observed in this area.

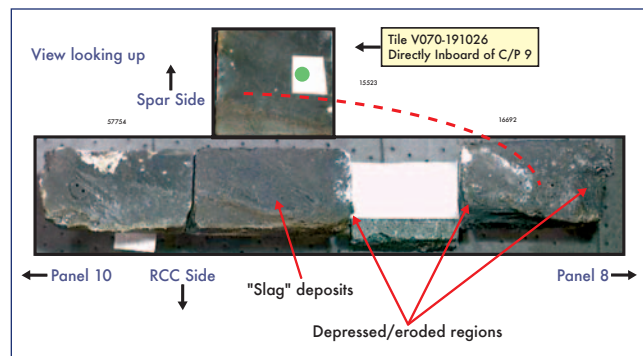
Figure 5-5. Flow on the lower carrier panel 9 tiles.

ure 5-4 and Figure 5-5 show an example of the rib erosion and the flow on the lower carrier panel 9.

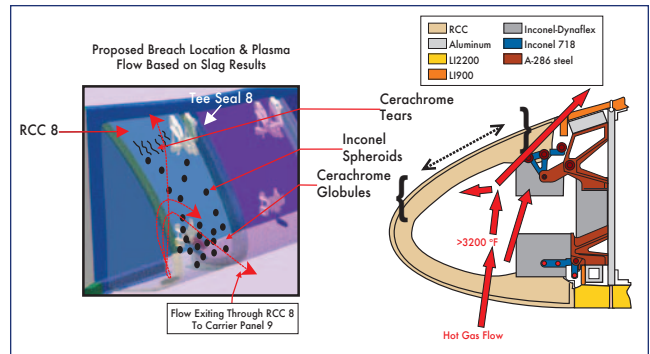
Figure 5-7. Analysis results show possible flow direction and deposition of metals.

As time progressed, the Cerachrome and Inconel wing spar insulators were eroded, and eventually hot gas flow impinged on the wing leading edge, burning through the honeycomb spar. Figure 5-7 depicts the possible flow direction and deposition of various metals as determined by this analysis.

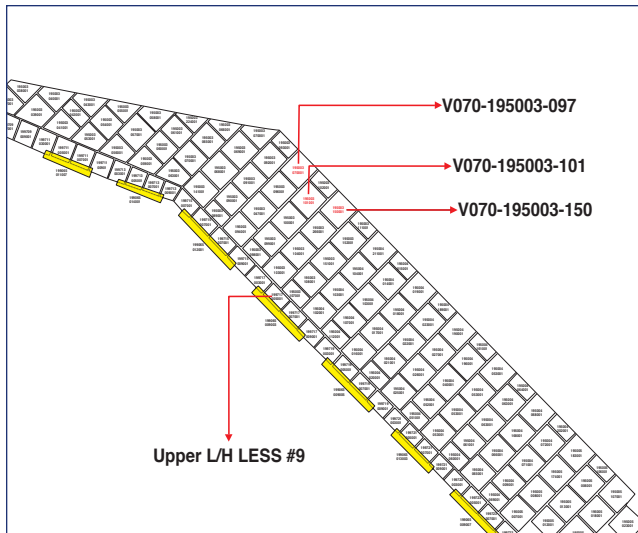
Figure 5-9. Three possible orbiter locations of the Littlefield tile on left wing.

ground track. This tile is the westernmost piece of debris that has been found to date in the debris recovery efforts. Due to the unique features of the tile (thickness, shape, paint, etc.), the tile must be from the upper wing area in the RCC panel 9 area. Figure 5-9 shows the only three possible locations for this tile.

The tile departed the orbiter more than one minute prior to final break-up due to prolonged internal heating of the upper wing skin in the area shown in Figure 5-9. The tile shows indications of backside heating and an RTV debond. It was not a failure in the densification layer, which would have been caused by mechanical loading. This piece of recovered debris is not very significant on its own merit; however, it is consistent with the previously discussed forensics data (rib erosion, carrier panel 9 tile slumping, etc.) and other events that will be discussed later in Section 5.4.

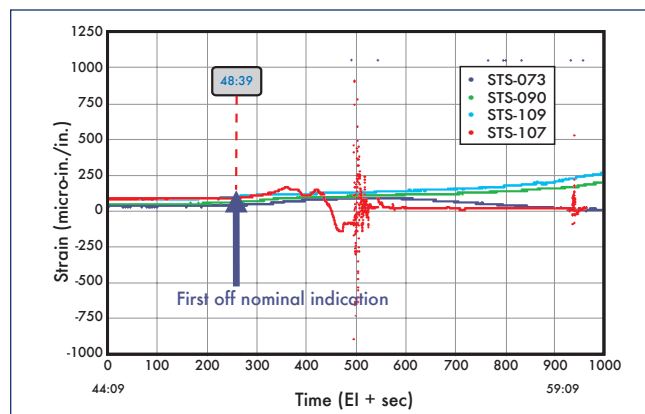
Figure 5-11. Left wing RCC panel 9 strain gauge is first measurement to indicate an off-nominal event. Note that EI was at 8:44:09 EST.

strain measurement along with three other previous *Columbia* missions. Figure 5-12 shows the location of this sensor (WLE Strain V12G9921A) and others on the wing leading edge. The damage in lower RCC panel 8 is believed to be the cause of this strain increase. The breach allowed hot gas intrusion onto the panels 8 through 9 wing leading edge spar area leading to extreme heating and thermally induced strain. The strain increase grew over time and reached a maximum at approximately 8:50:09 EST (EI + 360 sec.). Thermal and structural analyses indicate that a breach would need to be within approximately 15 inches of the strain gauge to create the observed strain increase.

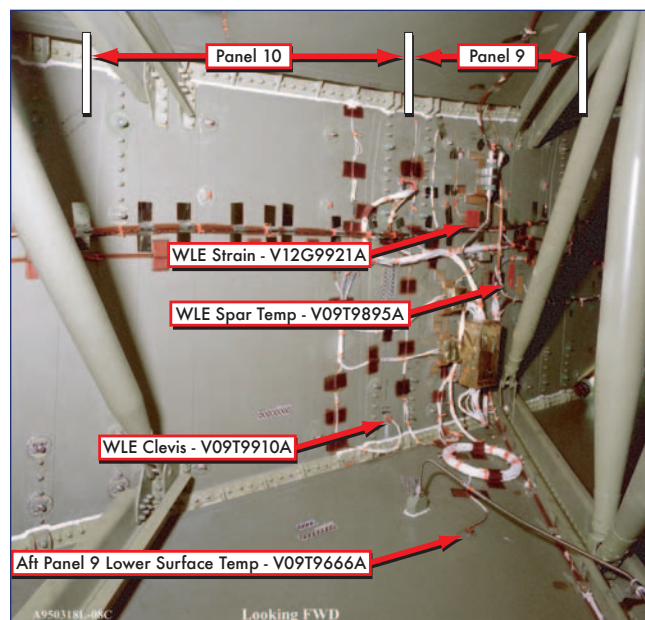
Figure 5-12. MADS sensors inside left wing.

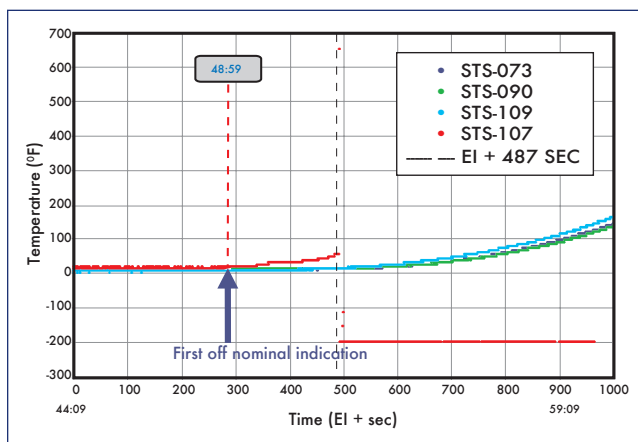
Twenty seconds later at 8:48:59 EST (EI + 290 sec.), the left wing lower attach clevis temperature sensor (between RCC panel 9 and 10) began an early off nominal temperature trend. Figure 5-13 shows the abnormal temperature response when compared to other *Columbia* missions. This temperature rise is consistent with an early entry of hot gas into the RCC cavity. This Modular Auxiliary Data System (MADS) measurement (V09T9910A) is the only temperature measurement located in the RCC cavity along the left wing leading edge. It is positioned on the lower attach fitting between panel 9 and 10 and is well protected thermally by Inconel foil insulation. The sensor is also thermally isolated since it sits on the attach fitting away from other structure as shown in Figure 3-12. In order to get an early temperature rise for this sensor, unlike that observed on any other flight, there must be a path in the RCC cavity to allow hot gas to reach the sensor.

A thermal analysis was performed with heating rates from various hole sizes in the bottom of RCC panel 8 in an attempt to match this temperature rise. The analysis used a thermal math model of the wing leading edge (Inconel Cerachrome insulation, Inconel 718 and A-286 steel attach fittings, and aluminum honeycomb spar). The results indicated that the heating equivalent of a 6 to 10 inch diameter hole with a 10 percent “sneak flow” around the insulation would be required to match the thermal response of the clevis temperature. In the same timeframe several MADS lower surface temperatures on the left wing showed a slight off nominal early temperature rise when compared to previous flights of *Columbia* of the same inclination.

Figure 5-13. Left wing RCC panel 9/10 clevis temp sensor is second measurement to indicate an off-nominal event.

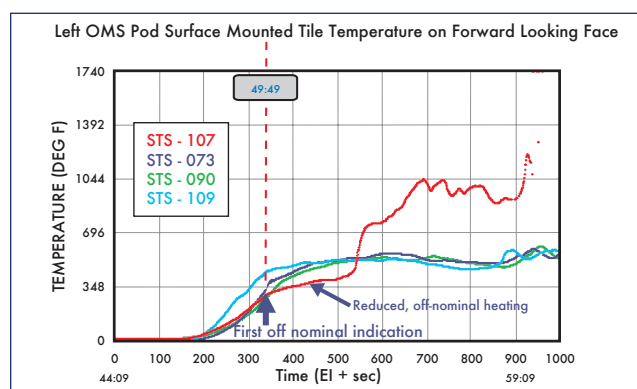
Figure 5-14. Typical off-nominal OMS pod thermocouple (V07T9220A).

The reduced heating is not completely understood since the weak aerodynamic flow field on the upper surface of the orbiter is difficult to model and is extremely sensitive to disturbances. The best explanation for this reduced heating is that flow into the RCC cavity was venting through to the upper surface of the wing through an existing 0.1-inch vent between the RCC and upper surface carrier panels. This vent exists all along the leading edge from RCC panel 1 through panel 22 and has an approximate area of 66 square inches. This upper surface RCC venting and the flow disturbance created by the panel 8 and upper carrier panel 8 damage caused the vortices from the canopy or area where the wing

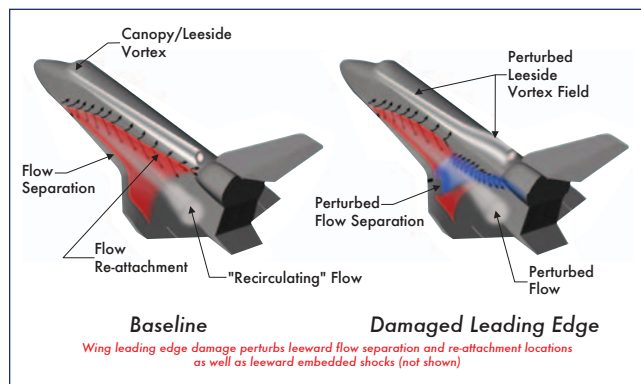
meets the orbiter fuselage to move from their normal positions, thus reducing the heating on the OMS pod. Figure 5-16 depicts the change in the upper wing surface vortices and the weak upper surface flow.

Figure 5-16. Postulated orbiter leeside flow field associated with wing leading edge damage.

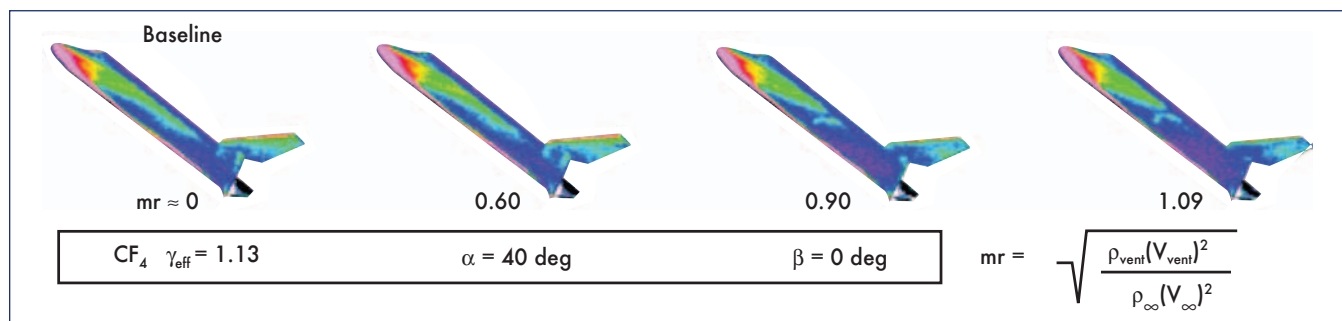
Figure 5-18. Wind tunnel model results for sensitivity of orbiter side fuselage and OMS pod heating patterns to mass addition along WLE leeside vent gap.

the RCC upper surface vent. Figure 5-18 shows the change in heating as the vent velocity is altered.

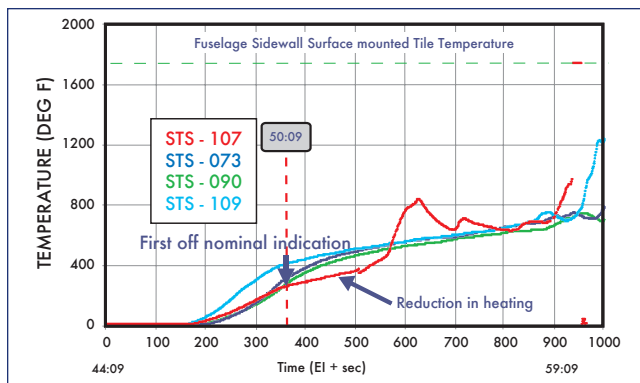
In the same timeframe, at 8:50:09 EST (EI + 360 sec.), a left payload bay fuselage MADS surface temperature measurement (Figure 5-19) showed an off-nominal temperature trend. This trend is a reduced rise rate when compared to other previous *Columbia* missions, as shown in Figure 5-20. The previously discussed theory of venting and or disturbed flow due to panel 8 damage, causing a shift in the vortices on the upper surface of the wing, is also believed to be the cause of this off-nominal behavior. The flow field and venting on the upper surface rate are constantly increasing since the mass flow rate into the RCC breach is increasing as the orbiter descends lower into the atmosphere.

Figure 5-20. Off-nominal temperature indication on the left sidewall.

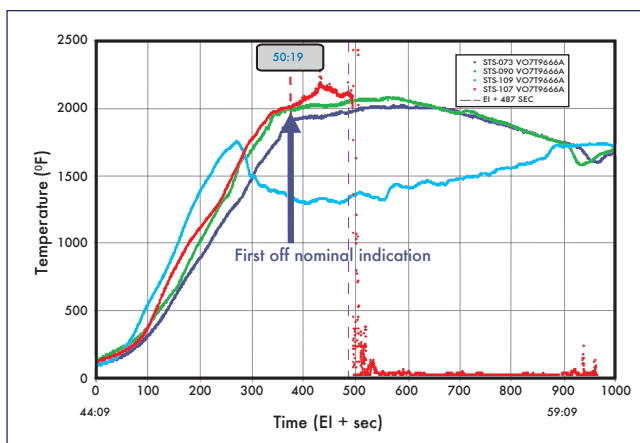
panel 8 will cause increased heating to the lower wing surface. As previously discussed, the eroded lower carrier panel tiles on panel 9 indicate this strong flow from panel 8. This is consistent with flow patterns observed on many recovered lower surface wing acreage tiles along the flow lines aft of the RCC panel 8 area. Figure 5-21 shows this temperature response as compared to other *Columbia* missions. The location of the sensor can be seen in Figure 5-22.

Figure 5-21. Temperature rise on tile surfaces aft of RCC panel 9.

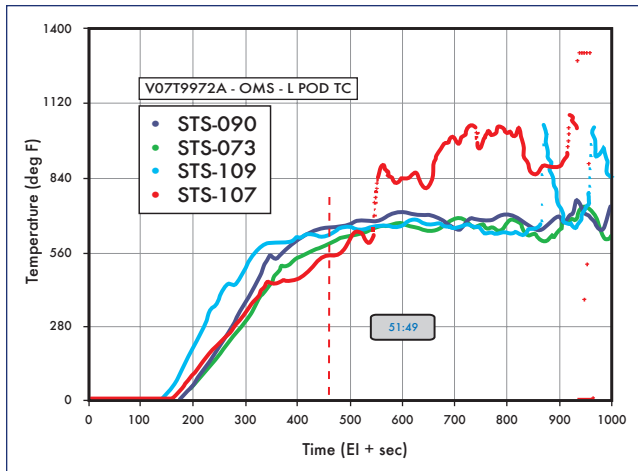
At 8:51:49 EST (EI + 460 sec.), one of the left OMS pod measurements (V07T9972A) began to show an increased temperature rise, indicating that the upper surface flow has changed again. This is shown in Figure 5-24 along with this measurement on other *Columbia* missions. It is evident that the measurement rises to a higher temperature and at a faster rate than has been observed on previous missions within the next few minutes. Figure 5-25 shows other left OMS pod and fuselage temperature measurements that exhibit an off-nominal rise later in time. The sensor locations on the left side of the orbiter are also shown in Figure 5-25.

Figure 5-24. Off-nominal low OMS pod thermocouple (V07T9972A).

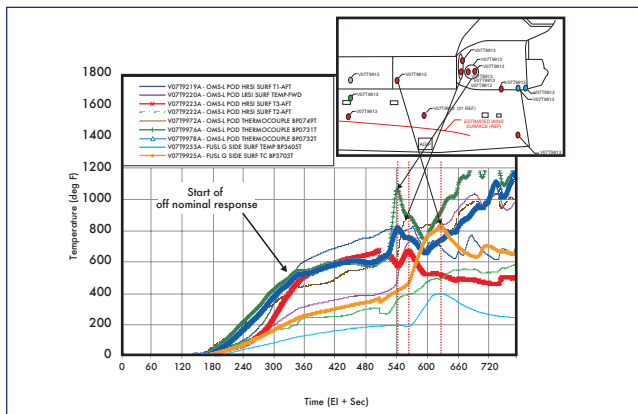
Figure 5-25. Left side fuselage/OMS pod off-nominal responses indicate increased heating.

These off-nominal temperature rises were caused by a change in the flow field along the upper portion of the left wing as the wing leading edge (WLE) and wing spar damage progressed. The mechanism was a shift in the vortices due to venting on the upper portion of the wing and is similar to the previous discussions on lower than expected OMS pod temperatures. Wind tunnel testing and CFD analysis confirmed that WLE damage on RCC panels 8 and 9 could cause increased heating to the OMS pod due to disturbed upper surface flow or flow impingement caused by re-directed flow from the lower surface. Additionally, the molten Inconel 718 and A-286 spray onto this area are indications that this flow is the cause of these temperature rises. Figure 5-26 (from wind tunnel test results) is a representative example of increased heating on the left fuselage and OMS pod due to RCC panel 9 damage from wind tunnel test results. Figure 5-27 shows a similar picture of the left side as determined by CFD analysis. Note that neither the wind tunnel testing nor the CFD analysis accounts for increased heating that is likely due to molten metal contacting the OMS pod.
